Key Words: stormwater, blue-green algae, odors, filamentous algae

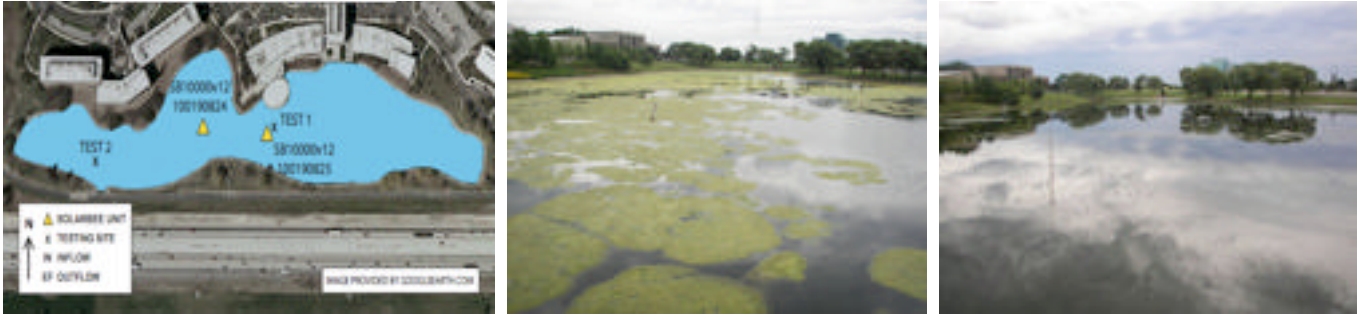
Photos: The aerial photo on the left indicates the locations of the two SB10000v12 units in the stormwater pond; the middle photo shows filamentous algae coverage in summer 2008; photo on right is from summer 2010 showing significant filamentous algae reductions.

Results: Since the SolarBees were installed in the stormwater pond, blue-green algae blooms and associated odors have been prevented. However, the combination of improved water clarity and the shallowness of the pond can create a favorable habitat for filamentous green algae to grow on bottom sediments, and eventually rise to the surface due to trapped metabolic gases. This scenario has been observed in other similar SolarBee installations during the first summer. This also happened in the customer's stormwater pond during the first summer (2008, see middle photo above). As also observed in other similar applications, enhanced sediment oxidation through SolarBee circulation has a negative effect on filamentous algal growth in the second and subsequent years after installation. By 2010, filamentous algae had been greatly reduced in this stormwater pond as well (see right hand photo above). No chemical treatments have been used since 2008, and complaints of unsightly algal blooms or noxious odors have also ended, which is very important as the pond directly faces corporate headquarters. They report the pond is now in "good shape", and they are very happy with the SolarBees and the significant improvements in pond ecology enhanced long-distance circulation has provide.
